INDOOR AIR QUALITY ASSESSMENT

**Sumner Avenue Elementary School
45 Sumner Avenue
Springfield, Massachusetts**

Prepared by:
Massachusetts Department of Public Health
Bureau of Environmental Health Assessment
December 2002

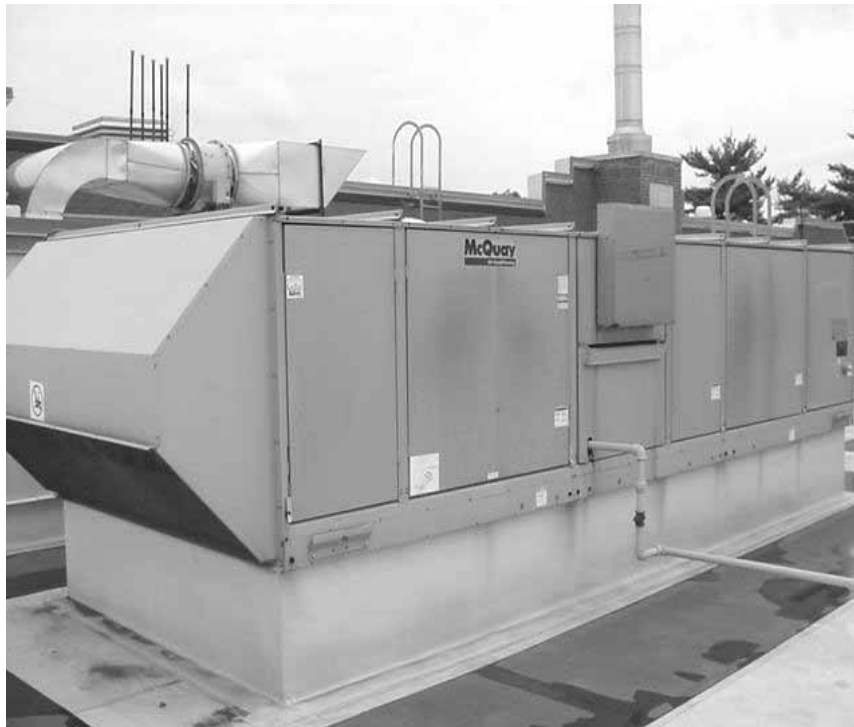
Picture 1

Fresh air in the SAES is provided by rooftop air handling units (AHUs) (see Picture 1). The AHUs provide fresh air via wall mounted fresh air diffusers connected to variable air

Rooftop AHUs

7. Consult a ventilation engineer to maximize the operation of all AHUs, VAV boxes and FCUs. Increase the amount of fresh air drawn by AHUs to increase comfort. Have the mechanical fresh air supply and exhaust balanced.

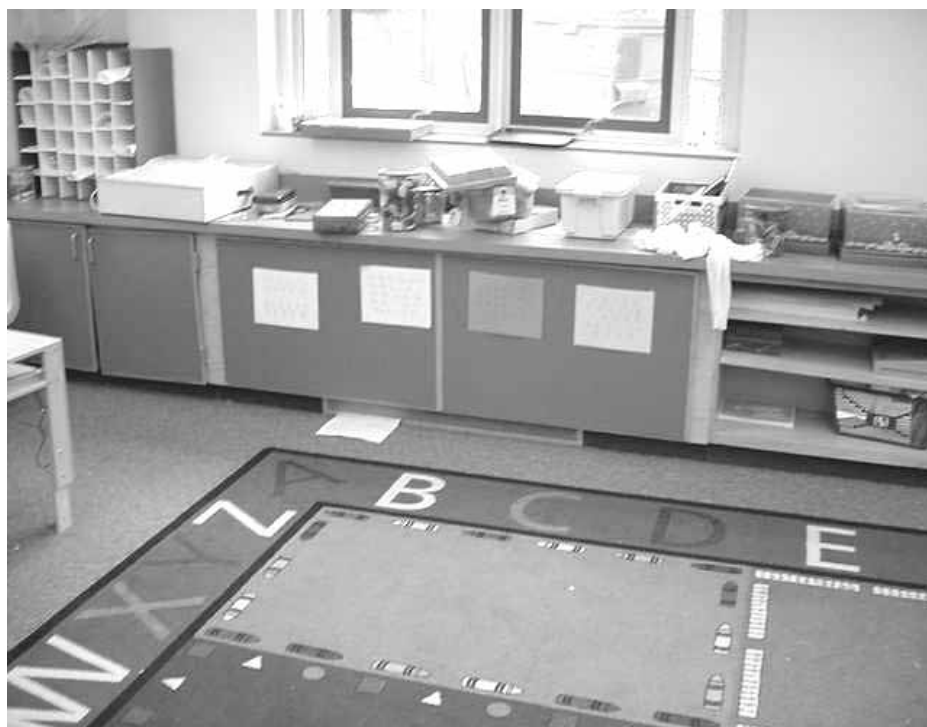
Picture 2

Heating and cooling is supplemented by a fan coil unit (FCU) (see Picture 2). Each FCU is located on exterior walls underneath windows. The FCUs are incapable of introducing fresh outdoor air. The FCU draws air from the room through a filter in the base of the cabinet into fans. Fans force air through coils that either heat or chill the air. Conditioned air exits the FCU through fixed louvers on the top of the cabinet. Fan coil units (FCUs) located at the base of

FCU in New Wing

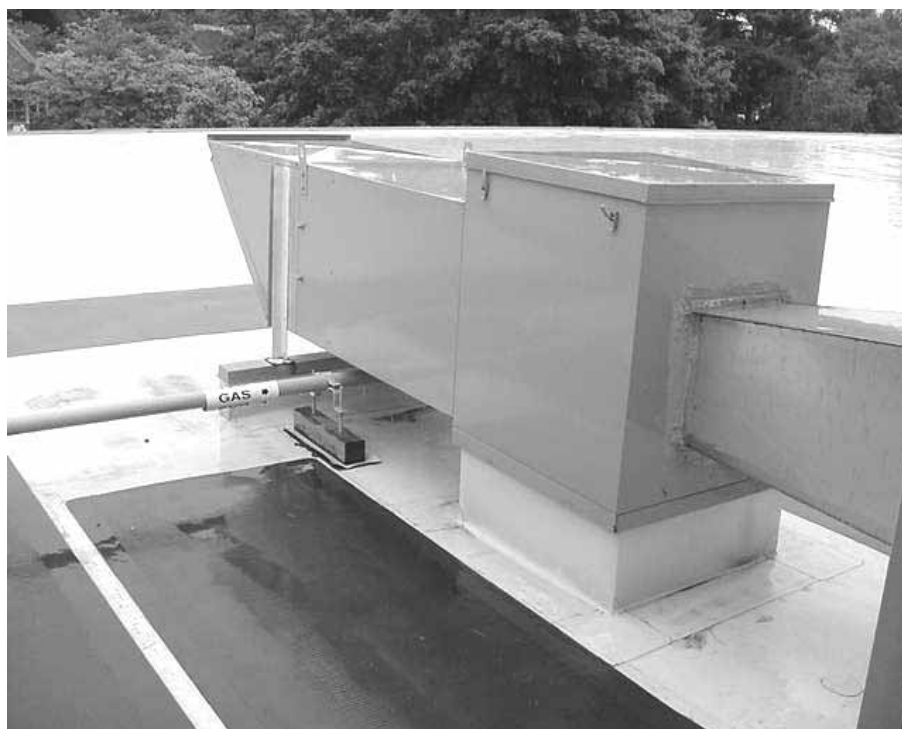
Picture 3

The operation of the make up air vent can result in unfiltered air and particles entering the building. The gymnasium ceiling passive vents and SAES can serve as potential pathways for outdoor particles. Cold outdoor air can sink into the building through inactive ductwork, creating a backdraft that can draw particles into the building.

Rooftop kitchen Gas-Fired Make Up Air Vent

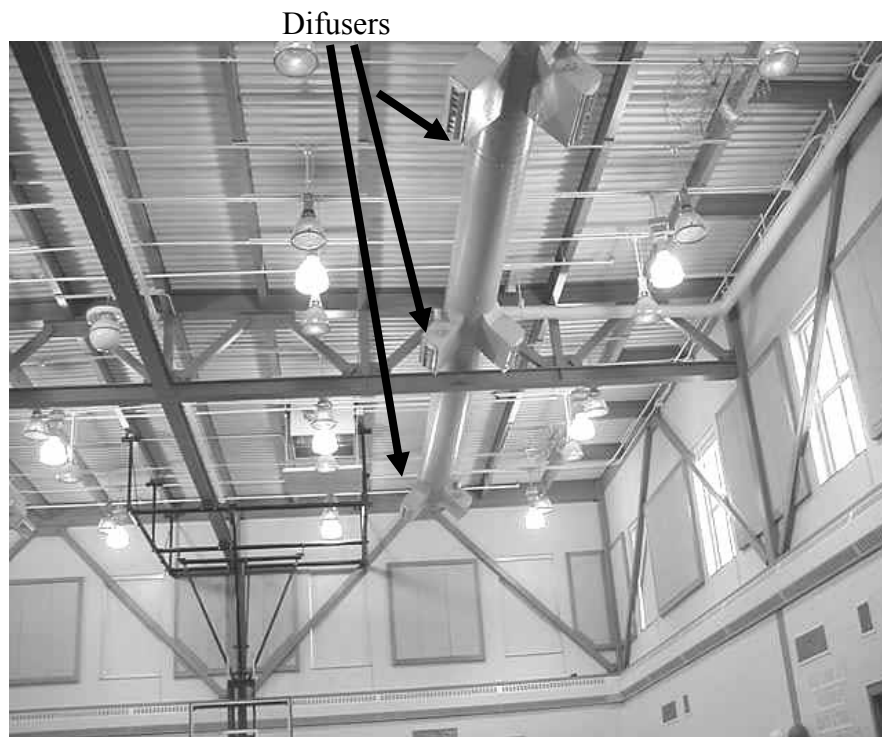
Picture 4

Other supplemental ventilation systems specific to certain areas were also identified. Two AHUs were found in the original wing attic. These AHUs provide fresh air to teacher rooms on the second floor. The kitchen has a gas-fired make up air vent (see Picture 3). The kitchen also has a large kitchen hood for the purpose of ejecting cooking/stove products of combustion from the building. The gymnasium has a separate ventilation system. Fresh air is provided by diffusers installed on ceiling-hung ducts (see Picture 4). The gymnasium also has ceiling fans.

Gymnasium Ductwork and Fresh Air Diffusers

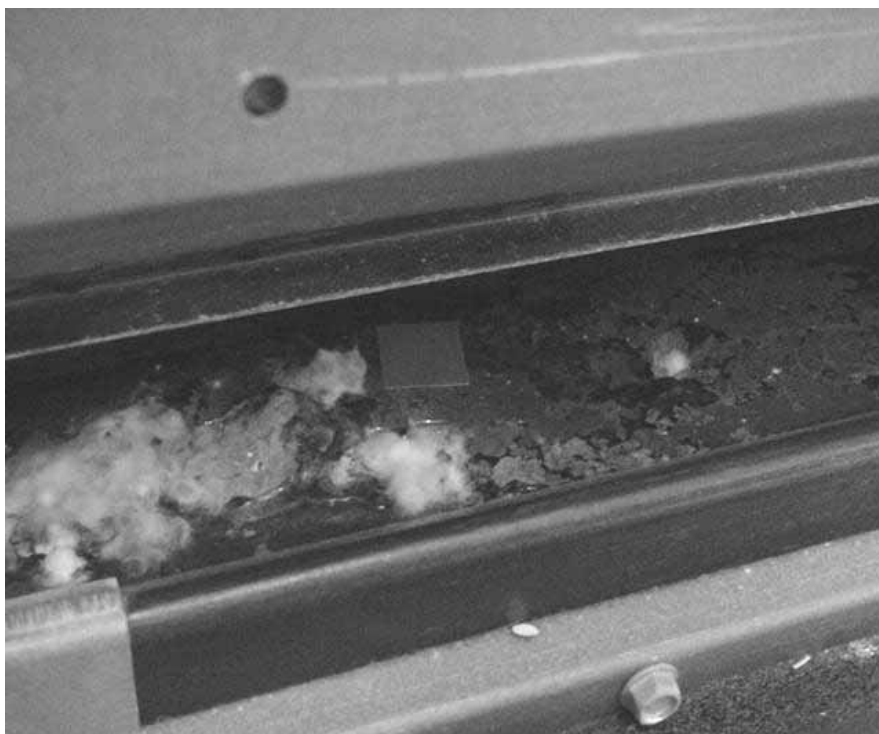
Picture 5

Mold Colony in FCU Drip Pan in Room 221

10. Clean accumulated mold and debris from the FCU drip pans. Enhance drainage by increasing the pitch of FCU drip pans.
11. Repair or replace all non-functioning FCU condensation pumps. These pumps should be tested every spring prior to activation of the air-conditioning system for function by pouring water into condensation pans and monitoring water removal. The interior collectors for condensation drains should be cleaned before and after the cooling season to prevent the accumulation of mold growth-supporting media.

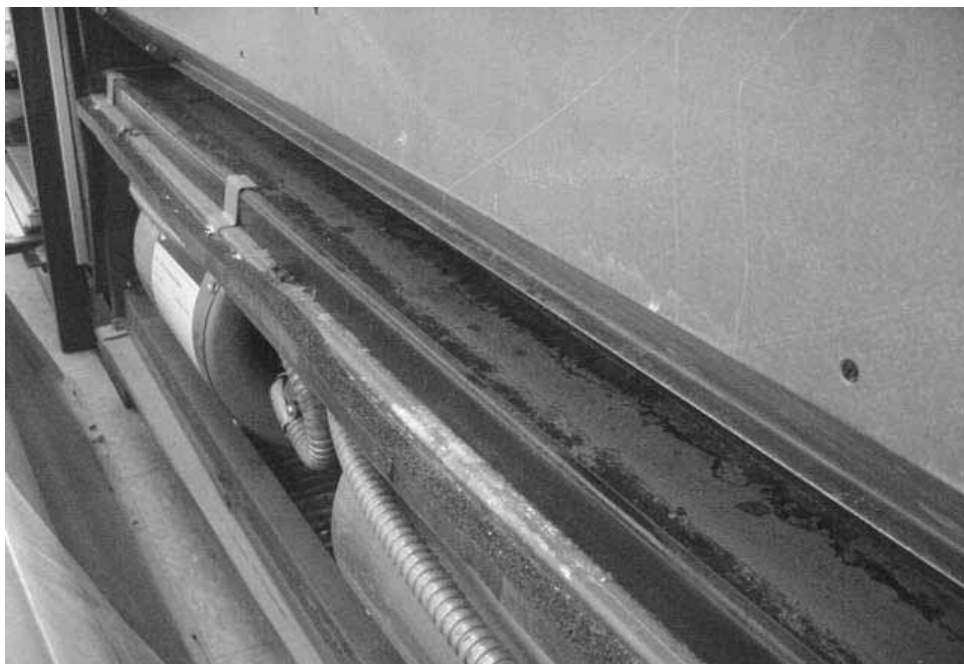
Picture 6

The HVAC system has the capacity to provide air conditioning during warm weather. Each AHU and FCU has pan/condensation drain system installed. When warm, moist air passes over a surface that is colder than the air water condensation can collect on the cold surface. Over time, water droplets can form, which can then drip from a suspended surface. For this reason, HVAC systems are equipped with drainage systems beneath cooling coils to drain condensate as moist outdoor air is cooled. Selected FCU drip pans were examined. All were found to be partially level, resulting in accumulation of water. Drip pans need to be beveled towards the drain in order to readily drain accumulated water. In room 221, a musty odor was detected. The drip pan in one of the FCUs was found to have an active mold colony (see Picture 5). BEHA staff poured approximately 12 fluid ounces of water into a univent drip pan to observe the rate of drainage. Most of this water appeared to pool in the drip pan with minimal drainage. In every univent examined, a characteristic pattern of accumulation of debris was noted, indicating that water accumulates within each pan (see Picture 6).

Accumulated Debris in FCU Drip Pan

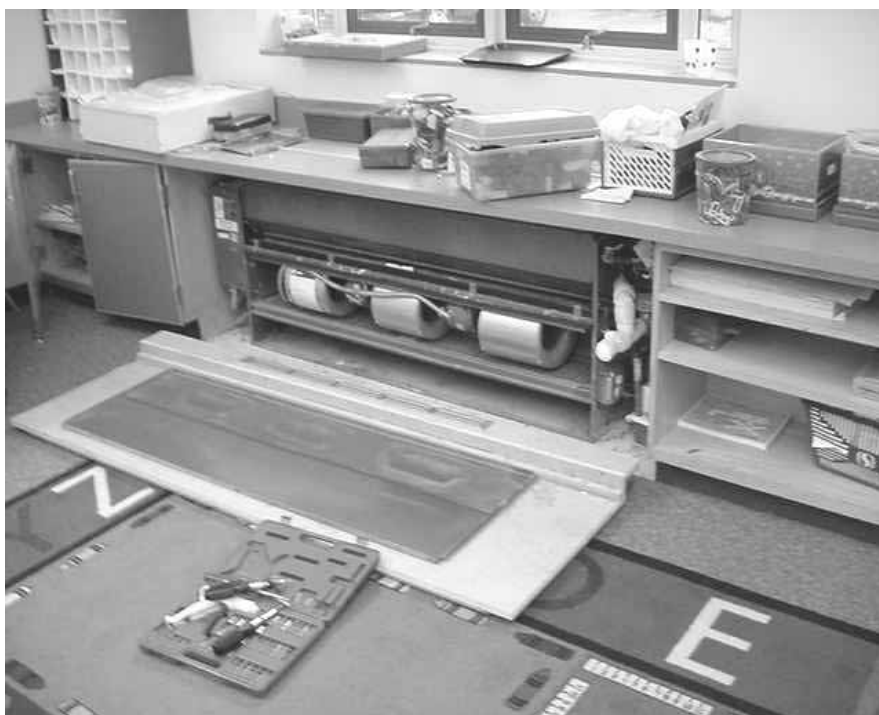
Picture 7

Of note was the condition of the casing of the FCUs. Instead of installing univents as a complete metal case as in the old wing it appears that the internal workings of a FCU were encased in specially designed wooden cabinets (see Picture 7) in the new wing. FCUs in the new wing appear to have a pattern of mold colonization of the wooden cover on the surface in contact with moving air created by the FCU (see Picture 8). In the air-chilling mode, the walls and drip pan of the FCU are reduced, which may produce condensation. Chilled air also reduces the

temperature of the sidewalls of the univent air-handling chamber, subsequently resulting in condensation generation inside the control and utility chambers. In order to avoid the generation of moisture, the underside of drip pans and the exterior walls of the univent air-handling chamber are usually insulated. No FCU examined had insulation installed on surfaces in contact with chilled air, which may result in mold growth.

New Wing FCU Were Encased in Specially Designed Wooden Cabinets

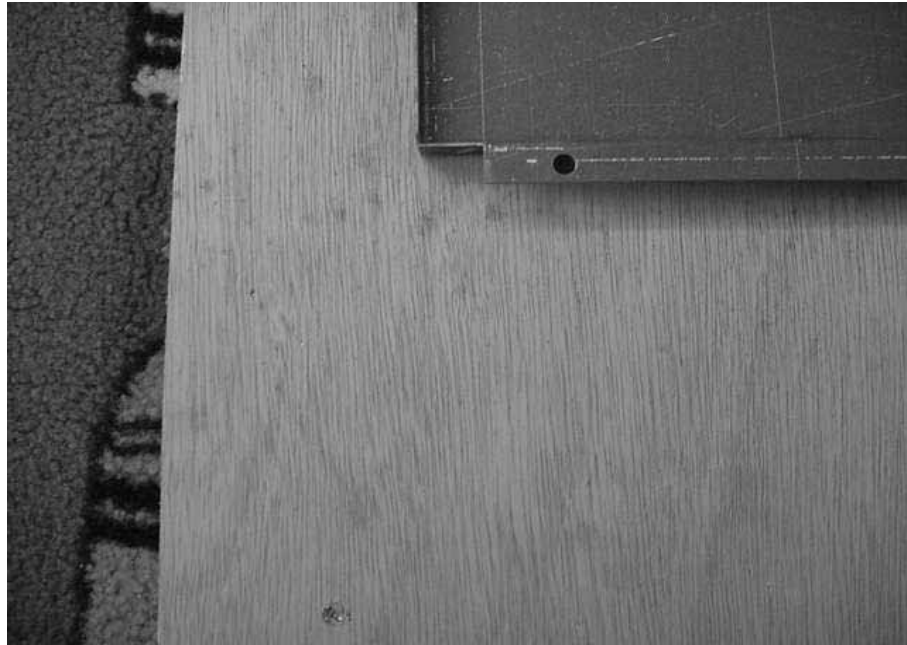
Picture 8

Wooden Cover of New Wing FCU, Note Subtle Spotting That May Indicate Mold Colonization

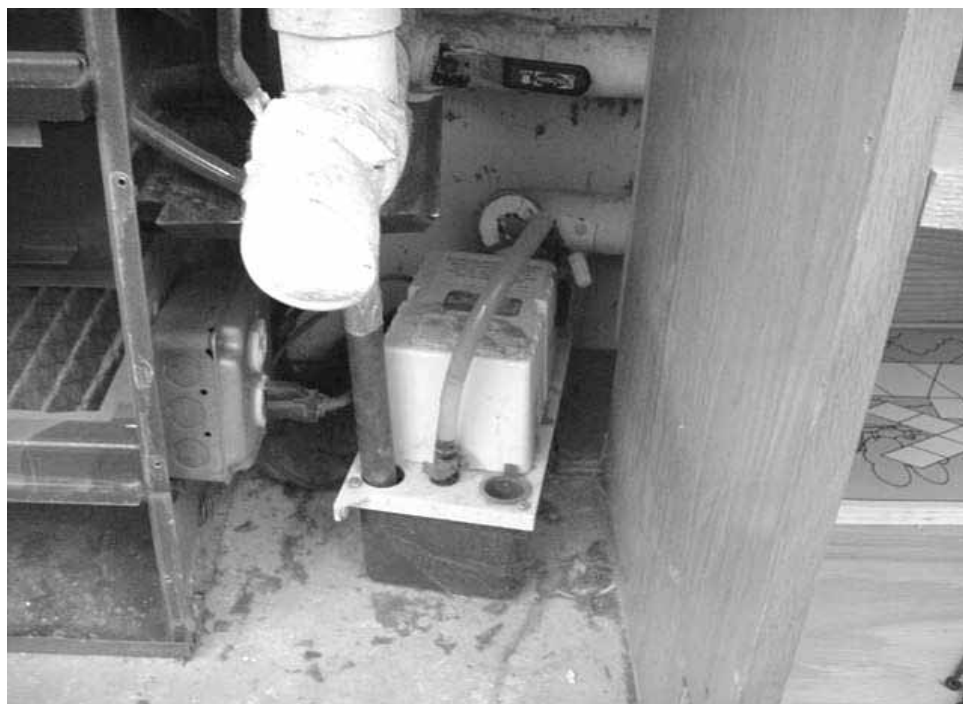
Picture 9

FCU condensation pans on the first floor in new wing and the ground floor in the old wing empty into a condensation pump (see Picture 9). The pump is connected to a pipe system that drains water away. Each pump should activate once water accumulates within the base of the unit. Five pumps were randomly selected and tested by the introduction of over 8 ounces of water into each device through the condensation drain. Four pumps failed to activate. One pump activated for approximately 10 seconds, then deactivated. All pumps failed to remove the majority of water collected within the pump water collector. This condition would result in water accumulating and pooling in the base of each pump. Condensation collectors in the pumps were heavily coated with debris that would serve as growth medium for microbial growth. Without drainage, it would be expected that these condensation pumps would remain filled with water for several days or weeks. Under this condition, each pump could potentially serve as a source of mold contamination.

FCU Condensation Pump

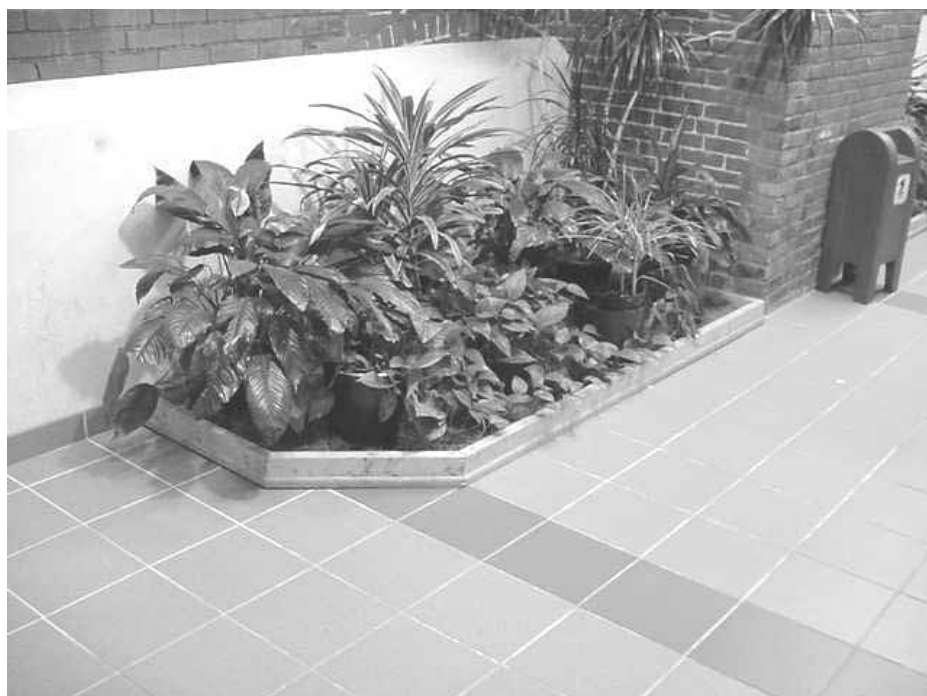
Picture 10

The atrium contains an interior garden with living plants (see Picture 10). Plants can be a source of pollen and mold, which can be a respiratory irritant to some individuals. Plants should be properly maintained and have adequate drainage.

Plants in atrium

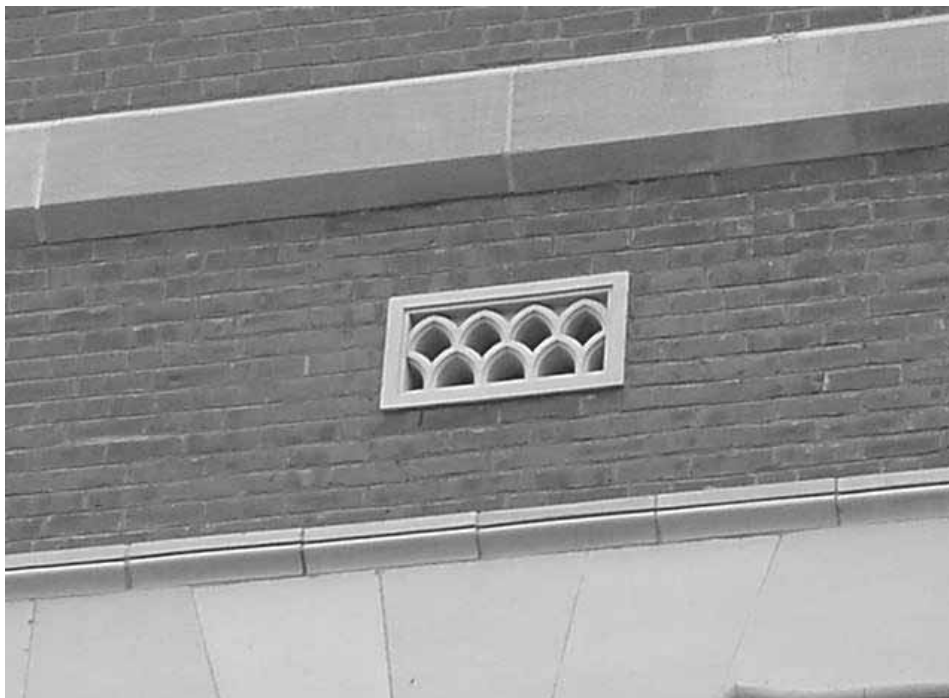
Picture 11

The attic of the original wing has a number of passive air vents (see Picture 11). Of note was the accumulation of bird nesting materials and wastes observed inside two of the passive vents with damaged or missing bird screens. Bird wastes in a building raise concerns over

diseases that may be caused by exposure to bird wastes. These conditions warrant clean up of bird waste and appropriate disinfection. Certain molds (*Histoplasma capsulatum*) are associated with bird waste (CDC, 2001; NIOSH, 1997) and are of concern for immune compromised individuals. Diseases of the respiratory tract may also result from exposure to bird waste. Exposure to bird wastes is thought to be associated with the development of hypersensitivity pneumonitis in some individuals. Psittacosis (bird fancier's disease) is another condition closely associated with exposure to bird wastes in bird raising and other occupational settings. While immune compromised individuals have an increased risk of health impacts following exposure to the materials in bird wastes, these impacts may also occur in healthy individuals exposed to these materials.

Passive Attic Vent

8. Clean bird waste in a manner consistent with methods described in the bird waste section.
9. Consideration should be given to rendering the boiler room as airtight as possible to eliminate the draw of combustion air to the occupied areas of the SAES. These measures would include installing weather-stripping along the doorframe and a door sweep at the bottom of the boiler room access door.

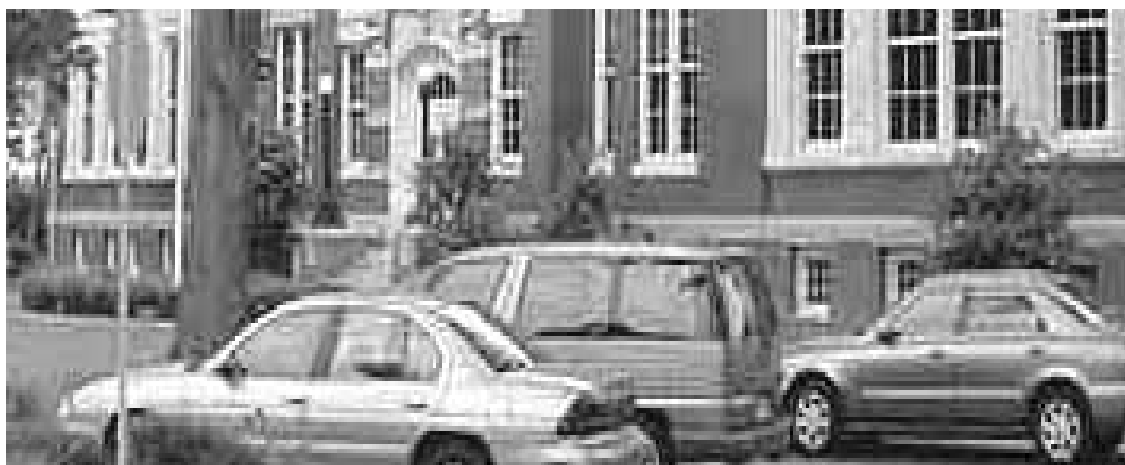
Picture 12

Shrubbery exists in close proximity to the foundation walls (see Picture 12). The growth of roots against the exterior walls can bring moisture in contact with wall brick and eventually lead to cracks and/or fissures in the foundation below ground level. Over time, this process can undermine the integrity of the building envelope and provide a means of water entry into the building through capillary action through foundation concrete and masonry (Lstiburek, J. & Brennan, T.; 2001).

Shrubbery in Close Proximity to Old Wing's Exterior Wall

14. Remove foliage to a minimum of five feet away from the foundation.
15. Improve the grading of the ground away from the foundation at a rate of 6 inches per every 10 feet (Lstiburek, J. & Brennan, T.; 2001).

16. Install a water impermeable layer on ground surface (clay cap) to prevent water saturation of ground near foundation (Lstiburek, J. & Brennan, T.; 2001).

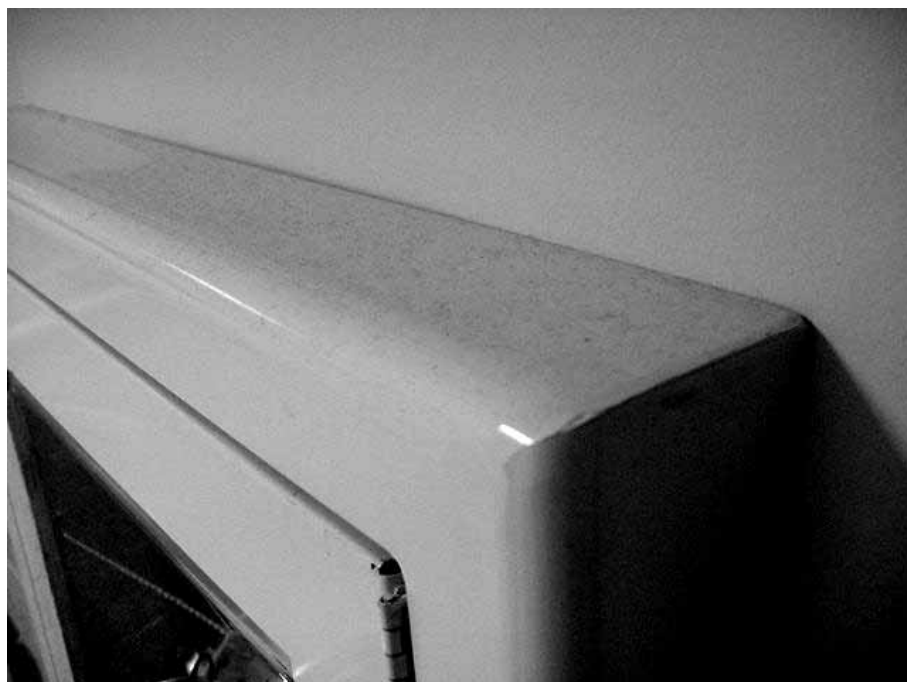
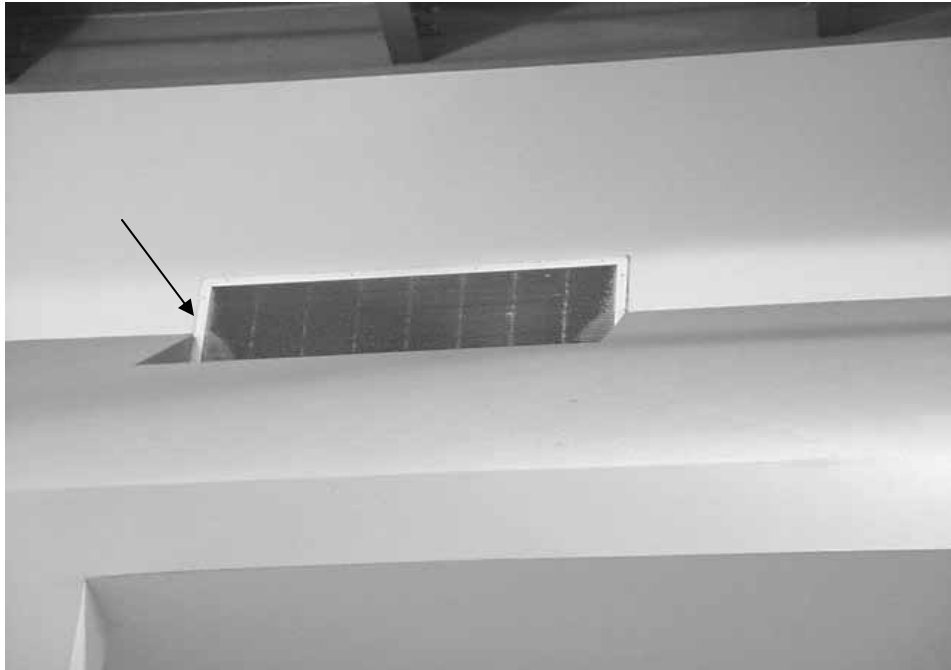
Of note was an accumulation of dust within the building, particularly within the hallways and gymnasium (see Pictures 13 and 14). As a result of building occupants concern about indoor air quality, the Springfield School Department commissioned a dust sampling study at the SAES (ATC, 2002). This study produced airborne dust sampling results that were below the outdoor air quality standards. The US Environmental Protection Agency has established National Ambient Air Quality Standards (NAAQS) for exposure to total particulate with a particle diameter of ≤ 10 micrometer (e.g., PM 10) in outdoor air . PM 10 levels in outdoor air must be

Dust Accumulation on Cabinet in Hallway

Dust Accumulation on Slopes Wall in Gymnasium, Note Accumulation of Dust on Return Vent

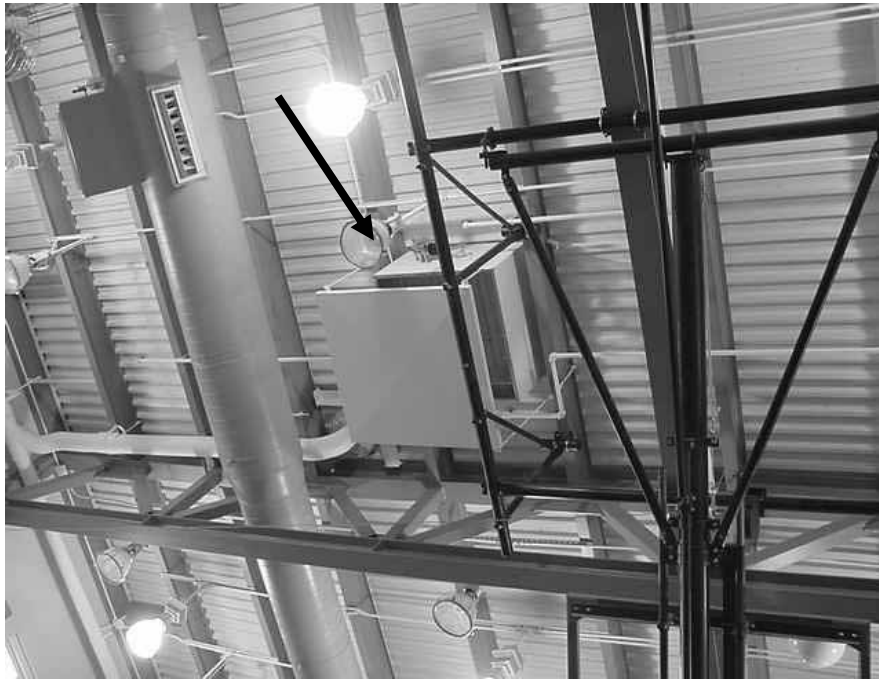
Picture 15

Gymnasium Passive Air Vents

1. Identify whether air backdraft dampers are installed in the SES components. If no backdraft dampers exist, consideration should be given to installing these devices.
2. Identify the purpose of the passive vents in the gymnasium ceiling. If open to the outdoors, consider installing a backdraft damper system to prevent unimpeded outdoor airflow into the gymnasium.

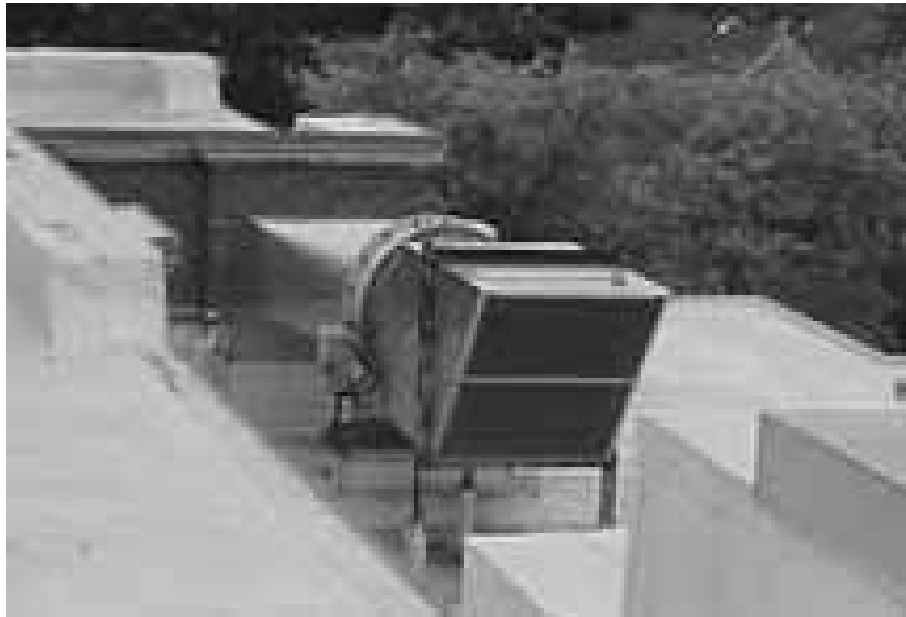
Picture 16

Fresh Air Intakes for SES

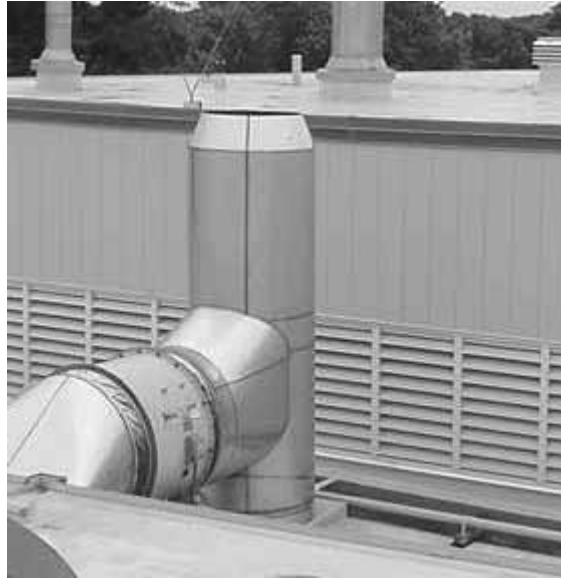
Picture 17

- The make up air vent for the kitchen has no means to insert filters to remove particles from its air stream.
- The SES exhaust vent and stack do not have a backdraft damper on the top of the stack (see Picture 17) nor in the ductwork (HMFH; 1997; see Blueprint 1).

Exhaust Vent for the Emergency Smoke Ejector System

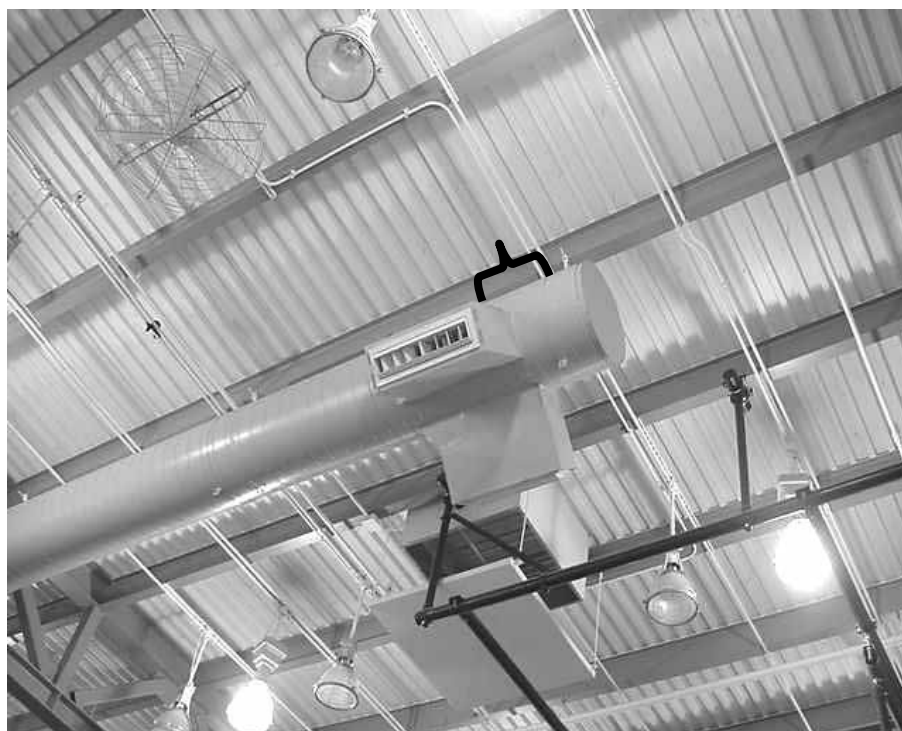
Picture 18

Of note is the configuration of the gymnasium fresh air supply ducts that may also provide a potential source of particles. Circular fresh air supply vents (HMFH; 1997; see Blueprint 2) were noted to have fresh air diffusers located several feet from the end of each circular duct (see Picture 18). The space at the end of each vent can accumulate debris and serve as a reservoir for particulates that can be distributed by the air diffusers. In addition the gymnasium ducts are likely to be internally lined with insulation. Since the HVAC system provides cooling during warm weather, internal insulation of these ducts would be necessary to prevent the generation of condensation on the exterior surface of the ductwork, which would in turn collect a drip onto the gymnasium floor. Internal lined ductwork may accumulate dust and debris that can be distributed into the interior environment.

Fresh Air Diffusers Located Several Feet from the End of Each Circular Vent in Gymnasium

12. Examine the ends of circular ducts of gymnasium vents for accumulation of debris and clean as needed. Consider opening the end of each circular duct and install a fresh air diffuser to reduce the dead spot in the bullpen and other areas with this condition.

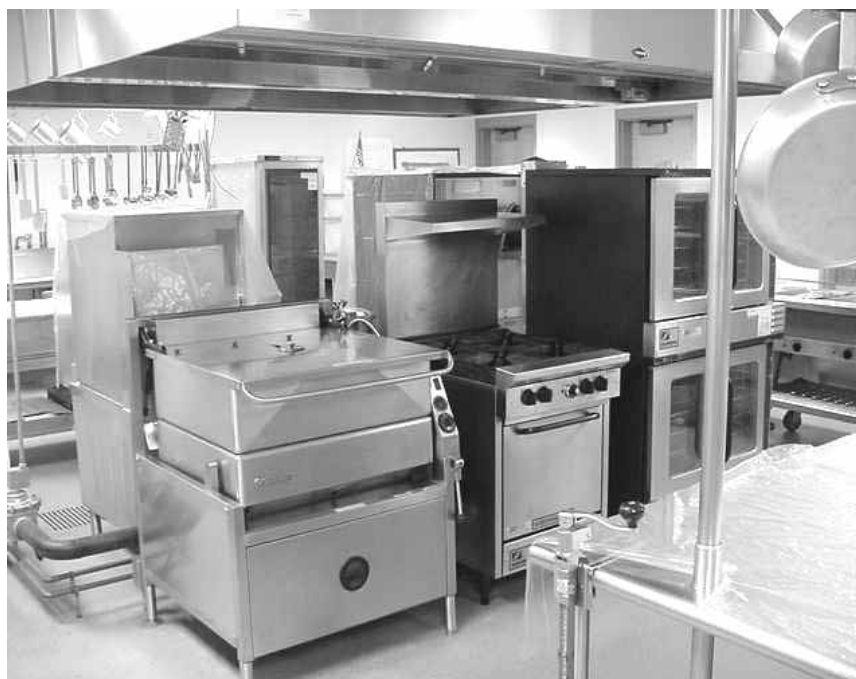
Picture 19

A second source of pollutants that can be introduced into the building relates to the kitchen. The process of combustion produces airborne liquids, solids and gases, including carbon monoxide (NFPA, 1997). The measurement of carbon monoxide can be used to pinpoint the source of combustion products. During the assessment, measurable levels of carbon monoxide were detected in the new wing. This source of carbon monoxide was traced to the kitchen. The kitchen uses a number of gas-fueled cooking devices (see Picture 19). The products of combustion and cooking odors are designed to be drawn in and subsequently ejected from the building via a large oven hood. The oven hood was deactivated at the time of these carbon monoxide air measurements. After lighting one burner on the top of the stove, carbon monoxide levels measured at the burner level were in a range of 15 parts per million (ppm). Therefore, it is likely the measurable levels of carbon monoxide were attributable to the use of gas-fueled cooking equipment without the oven exhaust vent hood activated. The oven exhaust vent hood was deactivated at the time of the carbon monoxide air sampling. The oven exhaust vent hood has three settings: “high”, “low” and “off”. After this measurement, BEHA staff recommended that the oven exhaust vent hood be operated in the low setting to provide exhaust ventilation for the gas pilot lights in each gas-fueled cooking device to avoid the accumulation of carbon monoxide in the kitchen and adjacent areas. Another source of carbon monoxide is a heating device installed for the kitchen that is located in the roof. A gas-fired make-up air vent for the kitchen was installed in the roof (HMFH; 1997; see Blueprint 3, Picture 3). This device directly heats fresh air drawn into it with open gas vents. This introduces heated air and gas products of combustion into the kitchen when activated. The process of combustion produces a number of pollutants, depending on the composition of the material. In general, common

Gas-Fueled Cooking Devices in Kitchen

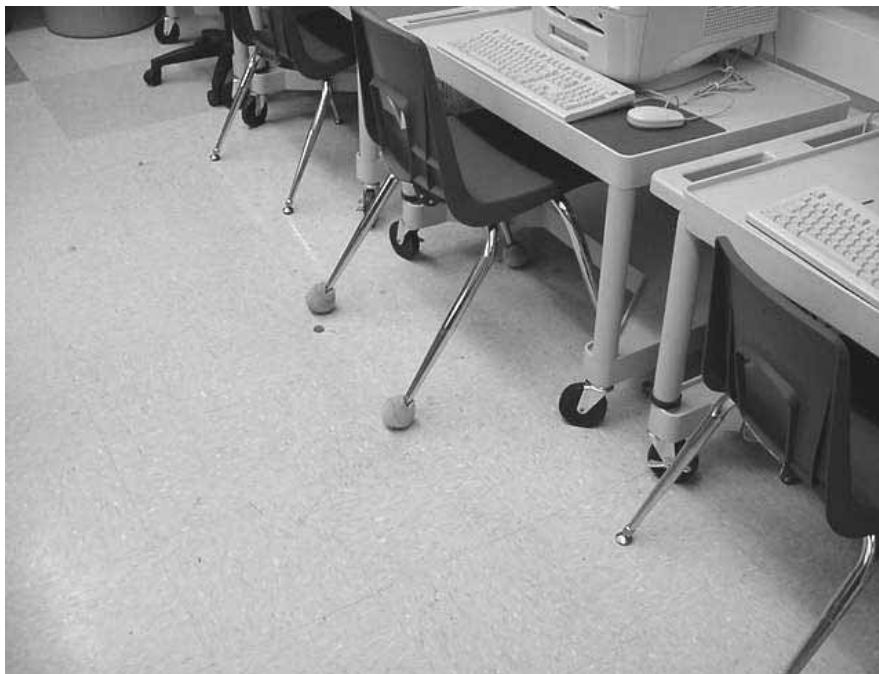
Picture 20

In an effort to reduce noise from sliding chairs, tennis balls had been sliced open and placed on chair legs (see Picture 20). Tennis balls are made of a number of materials that can be a source of respiratory irritants. Constant wearing of tennis balls can produce fibers and off-gassing volatile organic compounds (VOCs). Tennis balls are made with a natural rubber latex bladder, which becomes abraded when used as a chair leg pad. Use of tennis balls in this manner may introduce latex dust into the school environment. Some individuals are highly allergic to latex (e.g., spina bifida patients) (SBAA, 2001). It is recommended that the use of materials containing latex be limited in buildings to reduce the likelihood of symptoms in sensitive

Tennis Balls on Legs of Chairs

20. Discontinue the use of tennis balls on chairs to prevent latex dust generation.
21. Store cleaning products properly and out of reach of students.
22. Ensure exhaust ventilation is activated in work areas to help reduce lamination machine and photocopier odors.

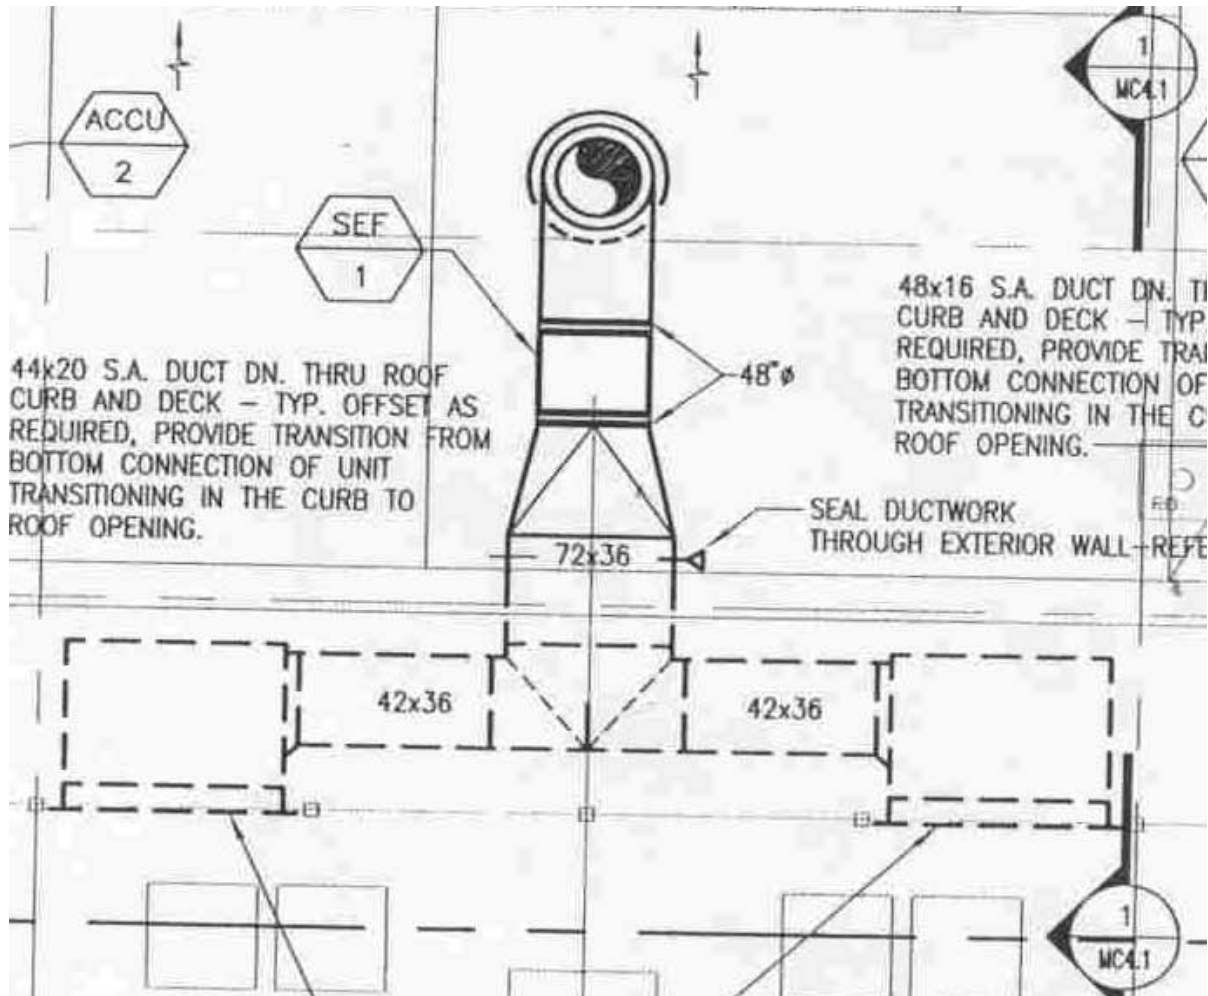
Blueprint 1

SES exhaust vent and stack do not have a backdraft damper on the top of the stack
(Plans would list component as BDD)

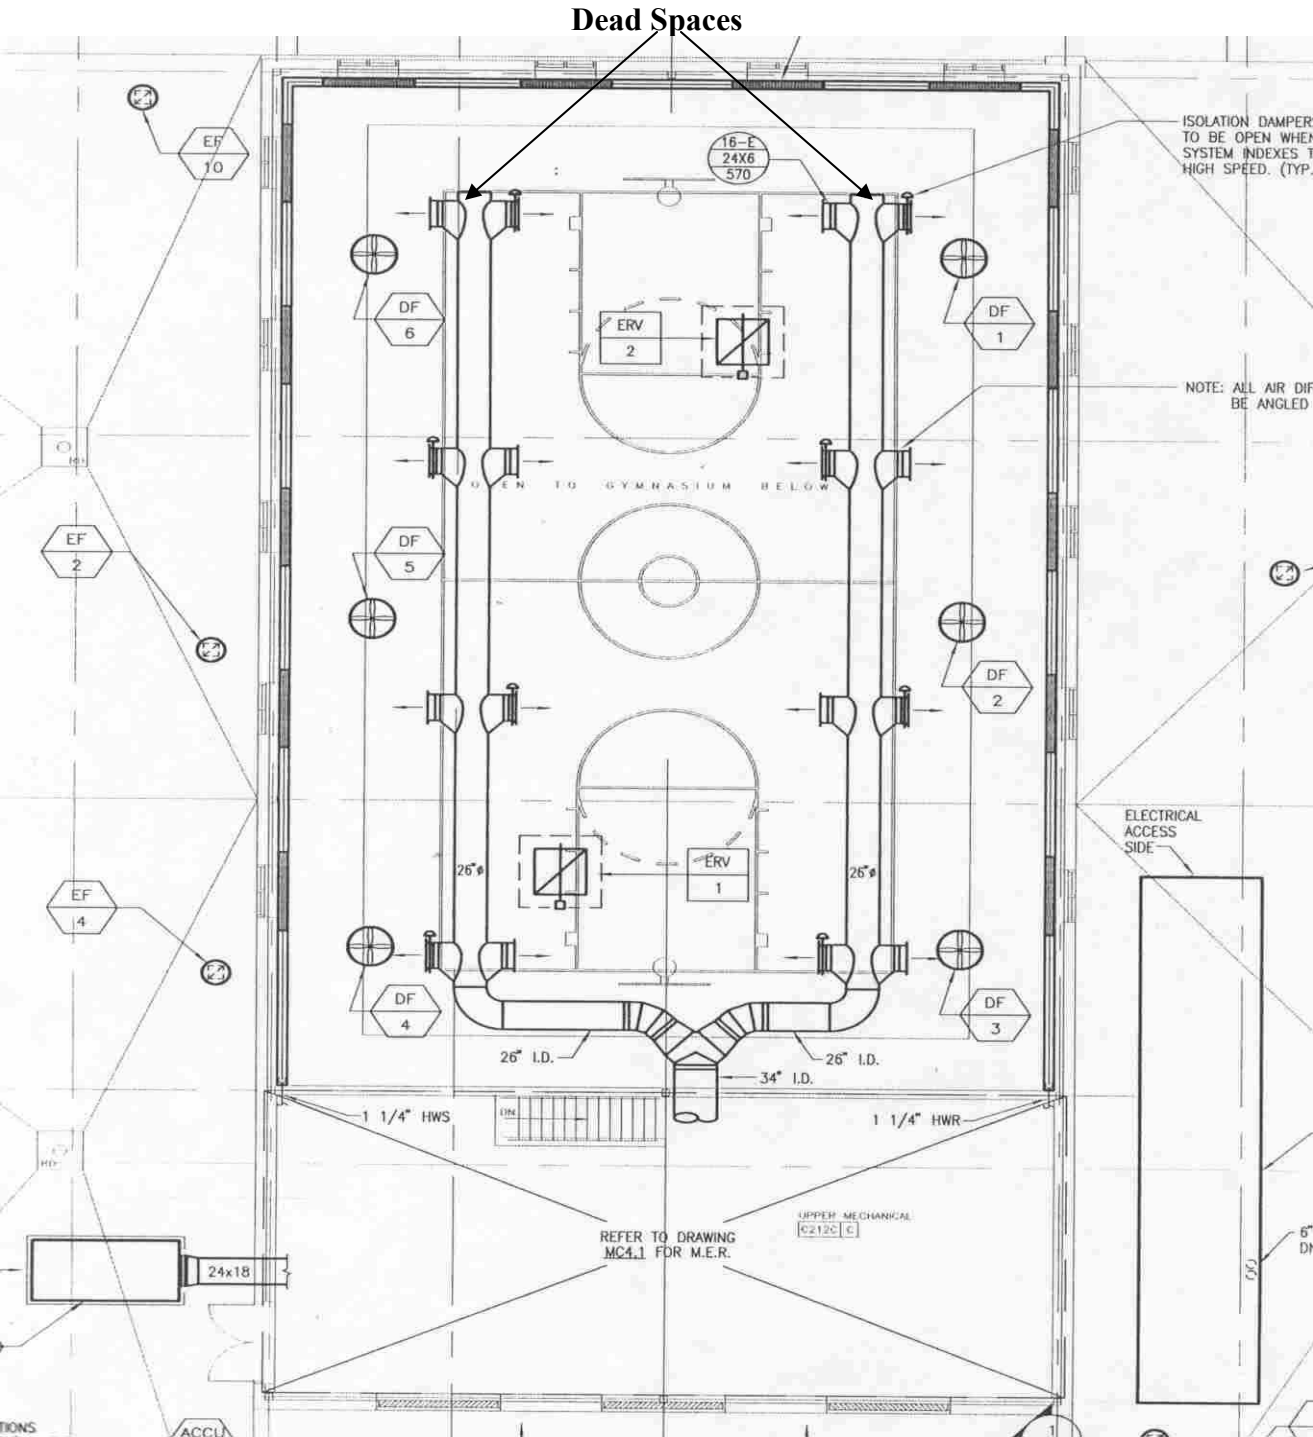
Blueprint 2

Gymnasium fresh air diffusers located several feet from the end of each circular duct, which creates a dead space to collect dust

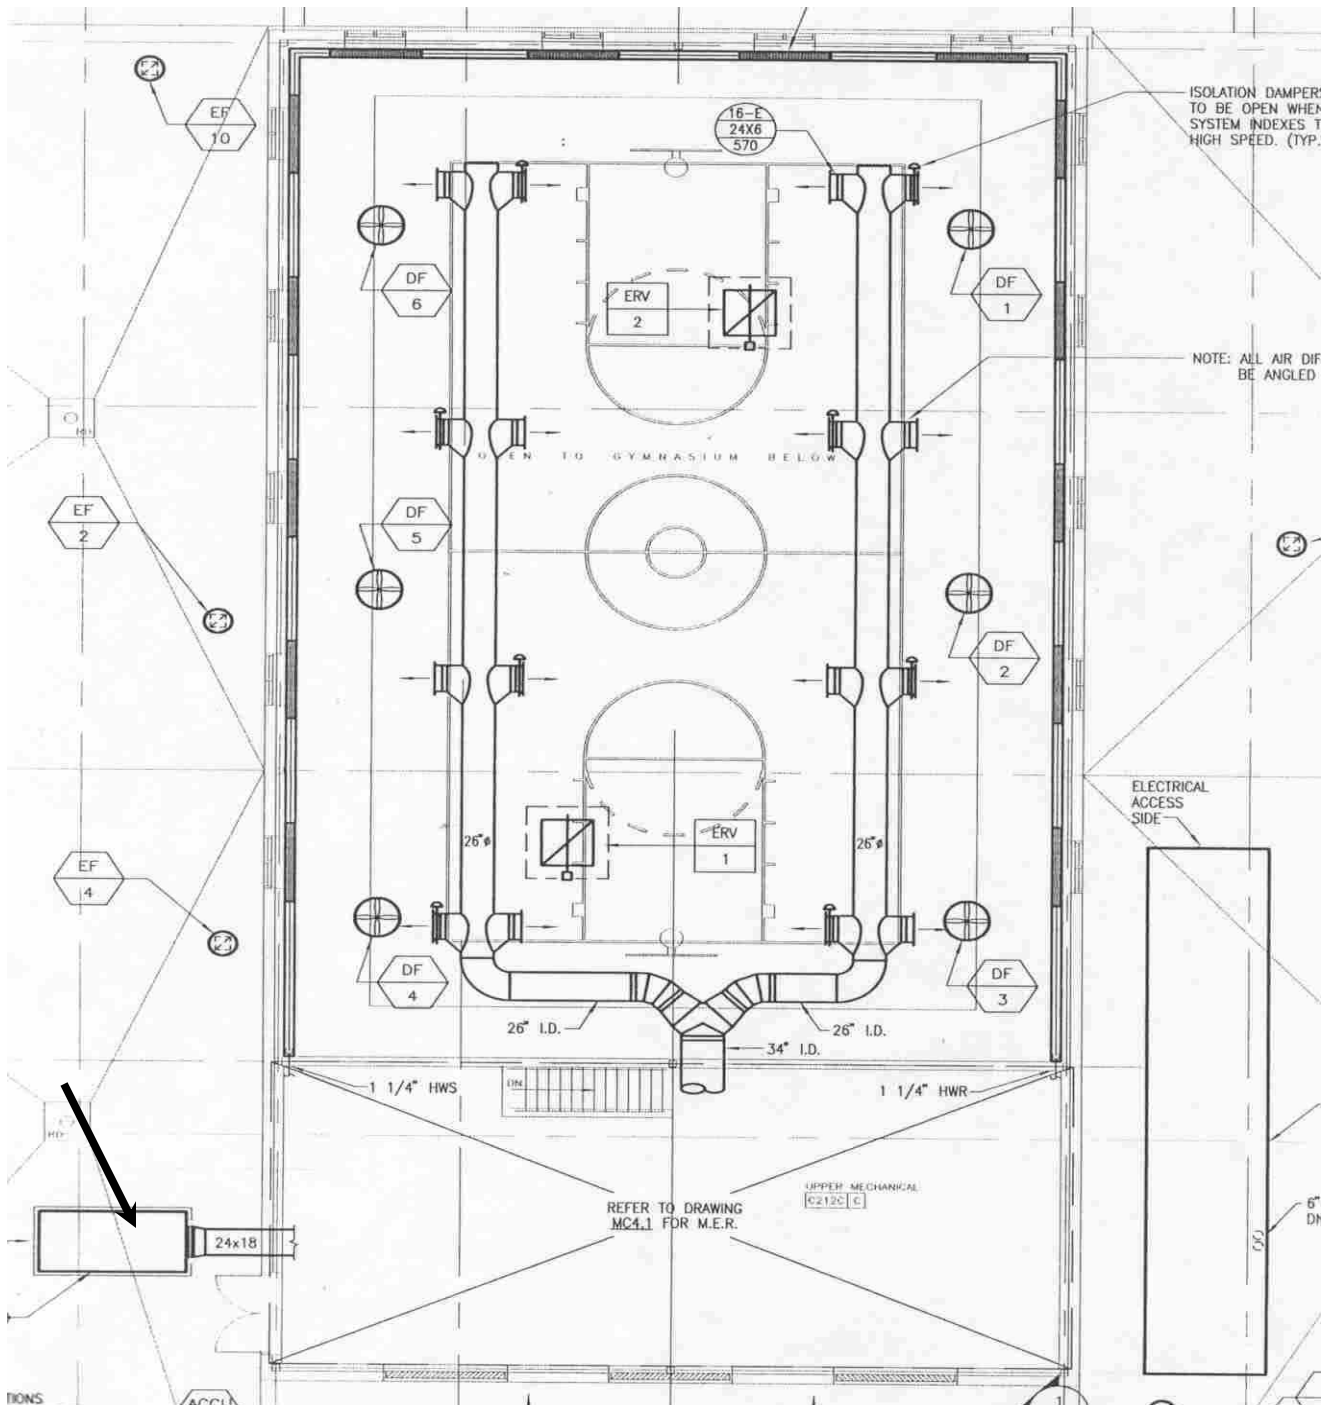
Blueprint 3

Gas-fired make-up air vent for the kitchen (indicated by arrow)
